# Manhole Inspection Summary

Manhole # S27E\_\_063MH

Insp Date: **8/24/07 9:33 AM**

**Location** Address: **126 AMITY ST**

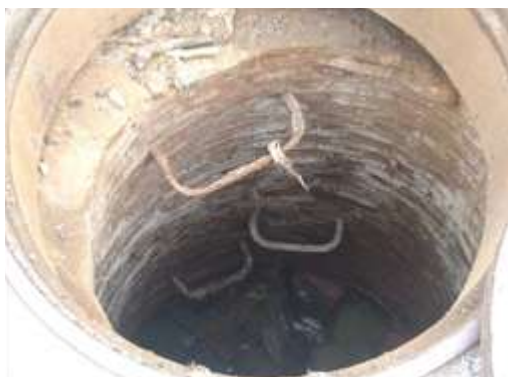
Defect 2

Count: **3** Missing: **2** ☒ **Corroded**

CORRODED AND MISSING STEPS

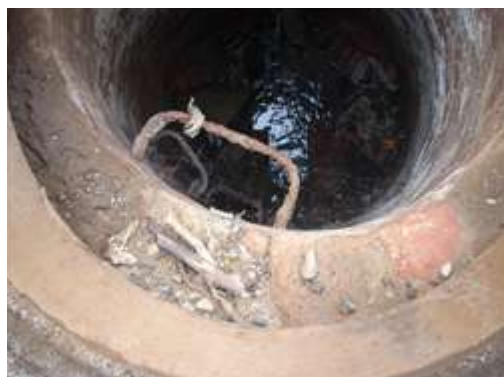
Defect 1

Offset: **4** (in.)

FRAME OFFSET

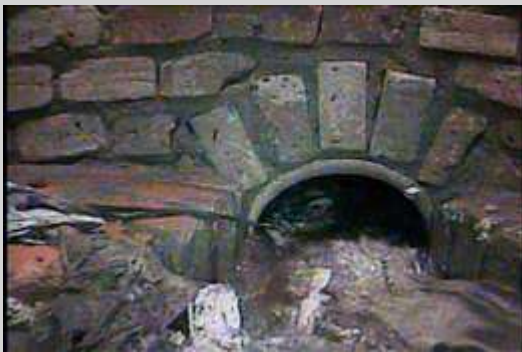
12 O'Clock Outflow

Pipe Height: **7.2** (in.) Rod and Bar (Angled)  
Pipe Material: **Clay** ☐ Pipe Lined  
Invert Depth: **9.32** (ft.) Flow Characteristics: **Slow**  
Deposits: ☐ None ☐ Mud ☐ Sludge ☒ **Debris** ☐ Grease  
Silt Depth: **4** (in.) Deposits Extent: **Heavy**  
Infiltration: **None** Pipe Seal Cond: **Sound**

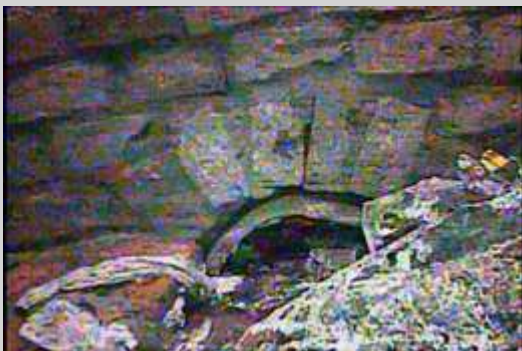
3 O'Clock Inflow

Pipe Height: **7.2** (in.) Rod and Bar (Angled)  
Pipe Material: **Clay** ☐ Pipe Lined  
Invert Depth: **9.14** (ft.) Flow Characteristics: **Slow**  
Deposits: ☐ None ☐ Mud ☐ Sludge ☒ **Debris** ☐ Grease  
Silt Depth: **6** (in.) Deposits Extent: **Heavy**  
Infiltration: **None** Pipe Seal Cond: **Sound**

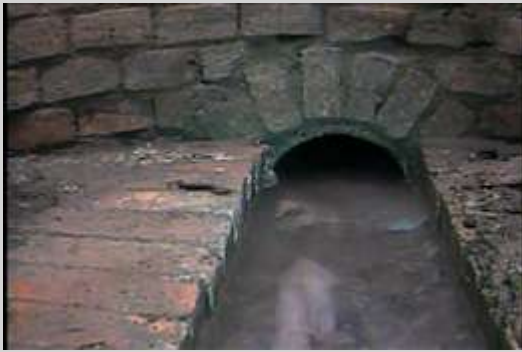
6 O'Clock Inflow

Deposits: ☐ None ☐ Mud ☐ Sludge ☒ **Debris** ☐ Grease

Silt Depth: **3** (in.) Deposits Extent: **Medium**
